HOME
report

SINGLE SURVEY
ENERGY REPORT
PROPERTY QUESTIONNAIRE
VALUATION REPORT

Single Survey

Property Address	31 Beck Avenue Larkhall ML9 1FN
Customer	Mr A Short & Mrs A Short
Date of Inspection	27/05/2026
Prepared by	Gary Macdonald Harvey Donaldson & Gibson Chartered Surveyors

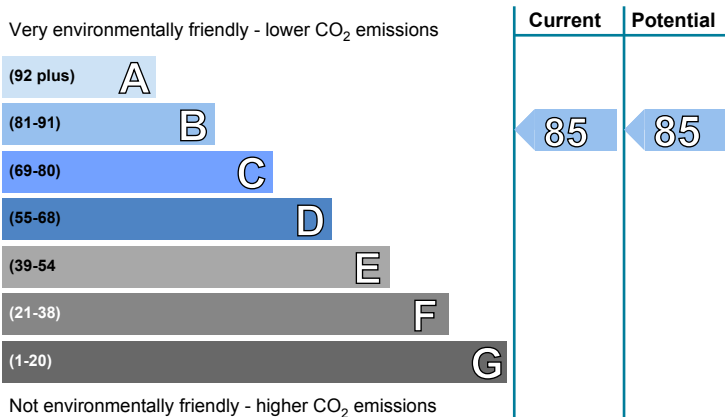
Environmental Impact (CO₂) Rating

This graph shows the effect of your home on the environment in terms of carbon dioxide (CO₂) emissions. The higher the rating, the less impact it has on the environment.
